Liskiewicz, T ORCID logoORCID: <https://orcid.org/0000-0002-0866-814X>, Kubiak, K and Comyn, T (2017) Nano-indentation mapping of fretting-induced surface layers. Tribology International, 108. pp. 186-193. ISSN 0301-679X

# Nano-indentation mapping of fretting-induced surface layers

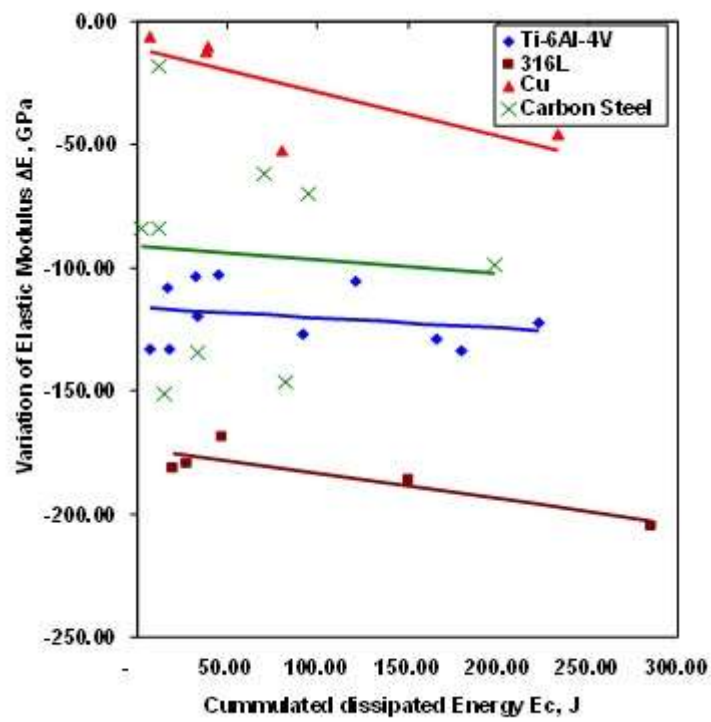
Figure 11

Fig. 11. Variation of Elastic Modulus for four tested materials as a function of cumulated dissipated energy.
